Full-scale embankment failure test under simulated train loading

V. J. LEHTONEN*, C. L. MEEHAN†, T. T. LÄNSIVAARA* and J. N. MANSIKKAMÄKI*

A full-scale embankment failure experiment was conducted in 2009 in Perniö, Finland. A small, extensively instrumented railway embankment on a soft clay foundation was brought to failure by loading over a period of 30 h. Instrumentation consisted of over 300 different measurement points, including 37 piezometers and nine automatically monitored inclinometer tubes. The relatively rapid loading simulated a heavy train coming to a standstill on the embankment. The primary purpose of the experiment was to gather field data of a failure caused by a rapidly applied load, with an emphasis on the pore pressure response in the clay foundation layer. The test was also used to assess the suitability of various instruments for real-time stability monitoring. The embankment failure was an asymmetric bearing capacity mechanism that is hypothesised to have been triggered by an undrained creep rupture. During the last 2 h of the experiment, pore pressure and displacements increased at an accelerating rate while the external load was kept constant. The time-de

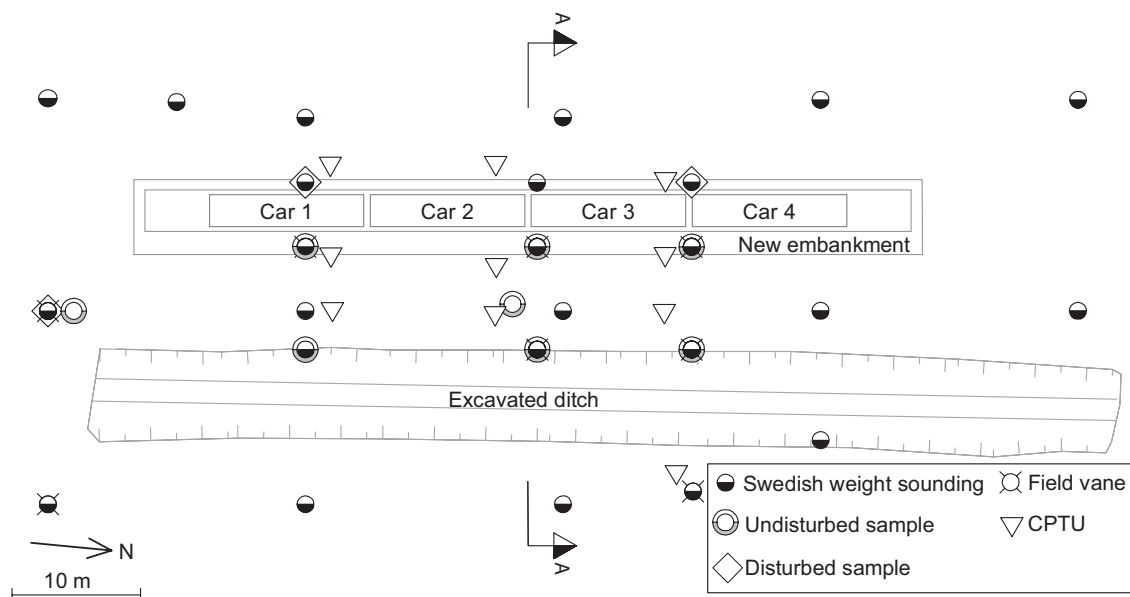
Fig. 2. Plan view of embankment test site showing location of soil borings and in situ tests

As shown in Fig. 2 and Fig. 3, a new 0.6 m high railway embankment having a length of 60 m was constructed at the existing track location, 9 weeks prior to the load test. The reason for constructing this new embankment (or 'ballast layer') was that the old superstructure was deemed to be too weak to support the designed loading. The old wooden sleepers and light rails from the original track were also replaced with concrete sleepers and heavier rails. The side slopes of this embankment were generally 1:2. To reduce the overall stability at the site, 10 weeks before the experiment a 0.3 to 0.6 m layer of top soil was removed next to the embankment. Additionally, a 2 m deep ditch, 7 m wide, with a 1:1.5 side slope on the embankment side was excavated approximately 13.5 m from the embankment centreline (Fig. 3), to further reduce stability and to control the extents of the failure.

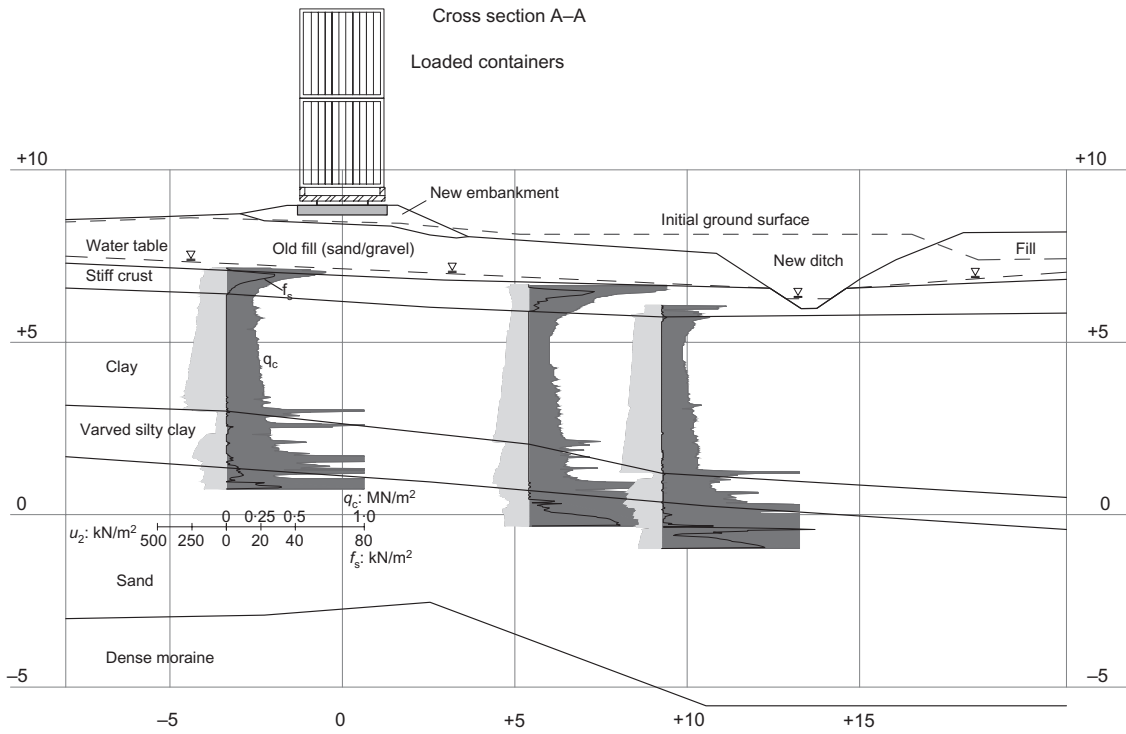
Fig. 3. Profile view of embankment test site showing soil stratigraphy inferred from the site investigation

The general foundation stratigraphy in the load test area was determined using information obtained during the soil exploration process; a typical cross-section from the site is provided in Fig. 3. As shown, the soil layers at the site (from

top down) consist of: (a) an old fill made of sand and gravel with a thickness of about 1.5 m; (b) a 0.6–0.9 m thick weathered clay crust layer; (c) a 3.5–4.5 m thick soft clay layer; (d) a varved silty clay layer composed of thin clay, silt and sandy silt layers with a thickness of approximately 1.5 m (the overall classification for this layer according to EN ISO 14688-2 (SFS, 2005) is a sandy silty clay); (e) a significantly stronger sand layer with a thickness ranging from 2 to 6 m; and (f) a dense glacial moraine layer in which the soil explorations were terminated. The initial ground surface elevation across the site generally ranged from +7.5 m to

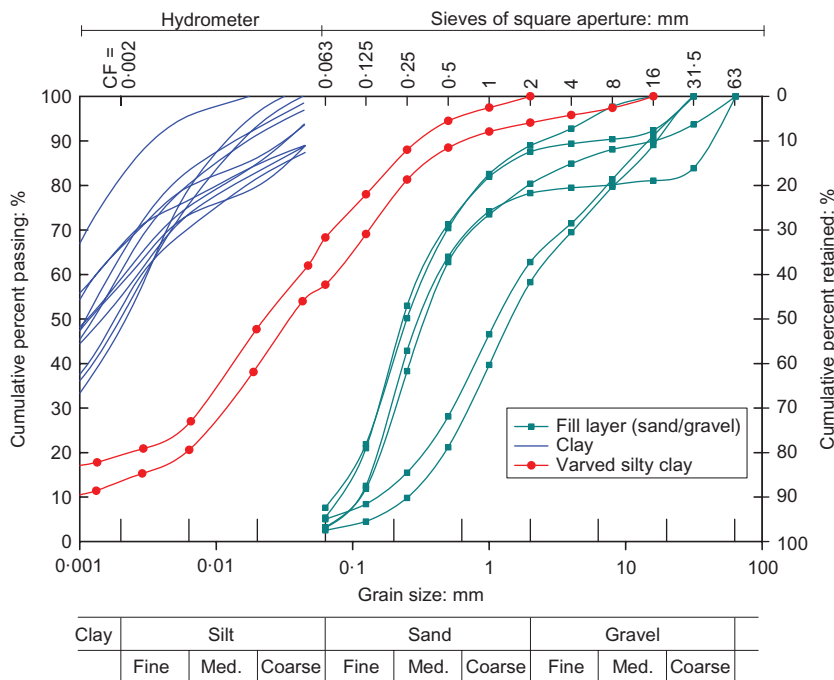
Fig. 4. Grain size analysis test results for Perniö soils

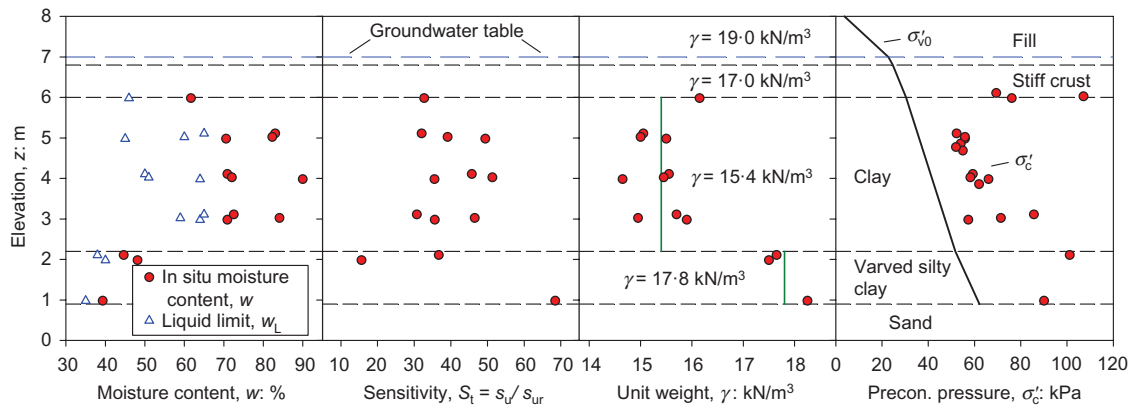
Fig. 5. General characteristics of Perniö clay, from samples taken at embankment toe

As shown in Fig. 5, the clay is slightly overconsolidated. The largest overconsolidation ratio (OCR > 2) is found in the top portion of the clay layer. The viscosity or rate dependency of the clay given by the ratio C_d/C_c was in the range of 0.06 to 0.08, which is typical for similar Finnish inorganic clays.

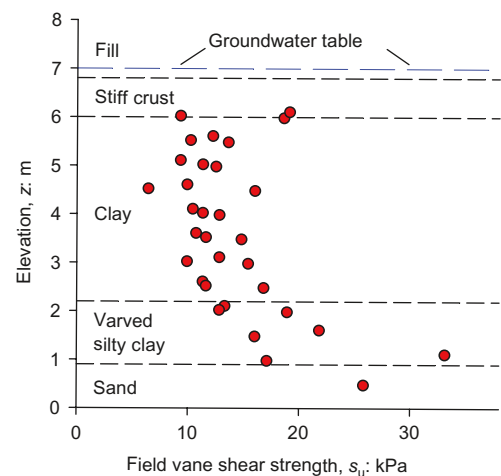
Fig. 6. Undrained strength characteristics of Perniö clay

Field vane shear test (in accordance with SGY (1999)) results from three combined soundings through the clay and varved silty clay layers are shown in Fig. 6. Near the top of the soft clay layer the minimum measured undrained shear strengths were in the range from 9 to 12 kPa and the average strength increase with depth was 1.15 kPa/m. A series of isotropically consolidated undrained shear triaxial compression tests were also performed, which indicated a peak friction angle of 25° for the soft clay.

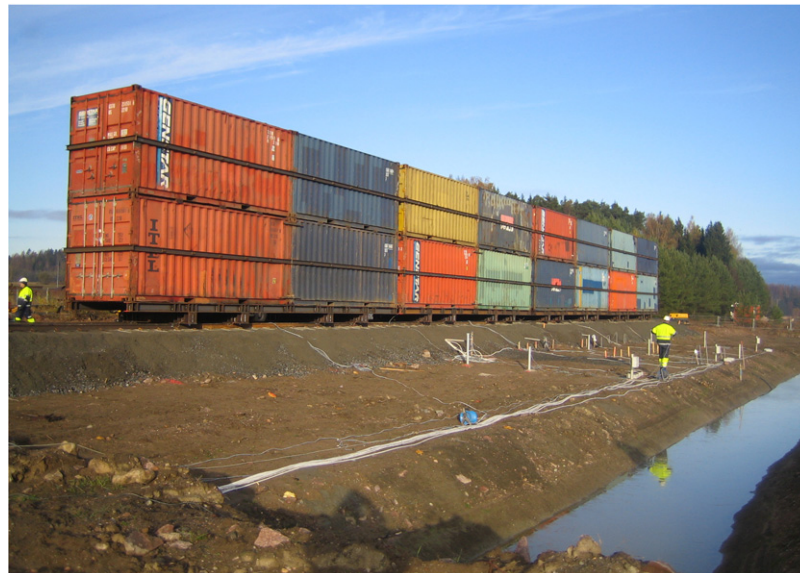
Fig. 7. (a) Test site and containers before loading; (b) container layout used to simulate train car loading pattern

A train coming to a standstill on the embankment was simulated by gradually filling modified shipping containers with sand. The containers rested on four steel frameworks that simulated four typical 12 m long two-bogey rail cars (Fig. 7). Each car had a stack of 2 + 2 containers. The tops of all containers and floors of the top containers were removed so as to be able to fill them without having to add the top row during the test. The frameworks distributed the load to the embankment by way of I-beams resting on the tracks. The

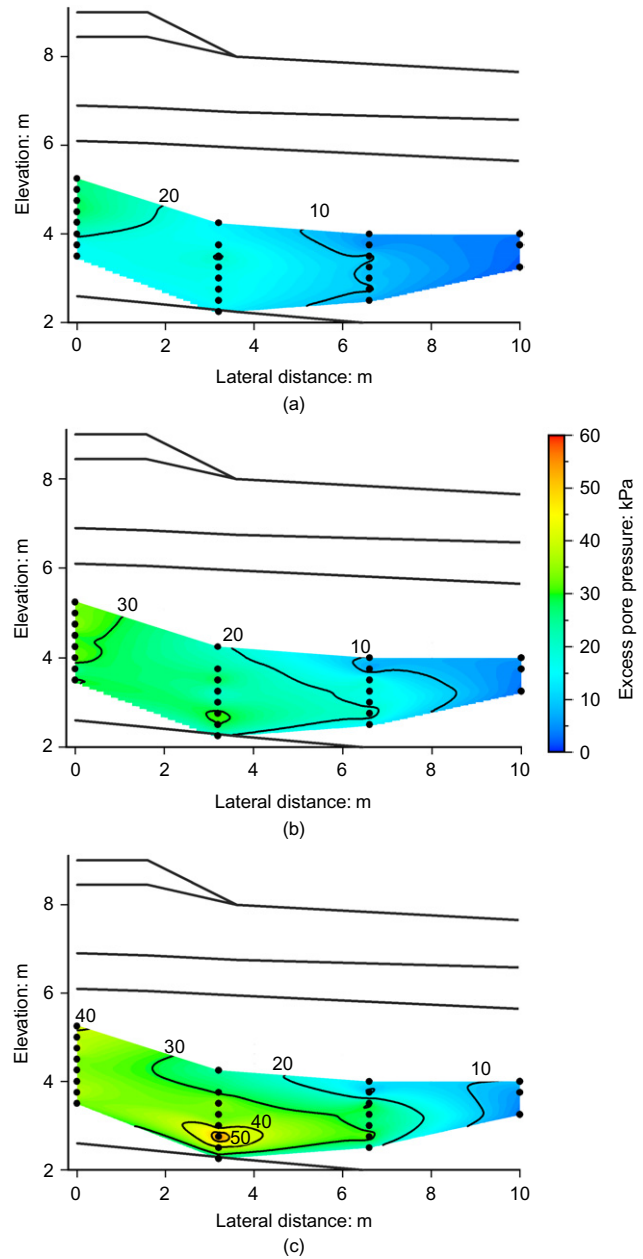
Fig. 12. Excess pore pressure profile inferred from piezometer measurements along cross-section A–A, at: (a) $t=28:00$; (b) $t=29:30$; (c) $t=29:57$. The full load has been applied at all stages. Piezometer locations are shown

Figure 12 shows the profile of excess pore pressure in the centre cross-section A–A at $t=28:00$ (end of loading), at $t=29:30$ (ca. 28 min before failure) and right before final failure. The contours are interpolated between individual readings (with the results from malfunctioning sensors omitted). The general shape of the slip surface and its progression with time at constant loading can be observed in the pore pressure contours.

The highest pore pressure at failure was measured at the toe of the embankment (Fig. 12). This pore pressure concentration may be due to the proposed sliding mechanism (Fig. 16) where a downward-moving ‘active’ soil block may have transitioned into a more horizontally displacing sliding mass, causing large strains and stress concentrations.

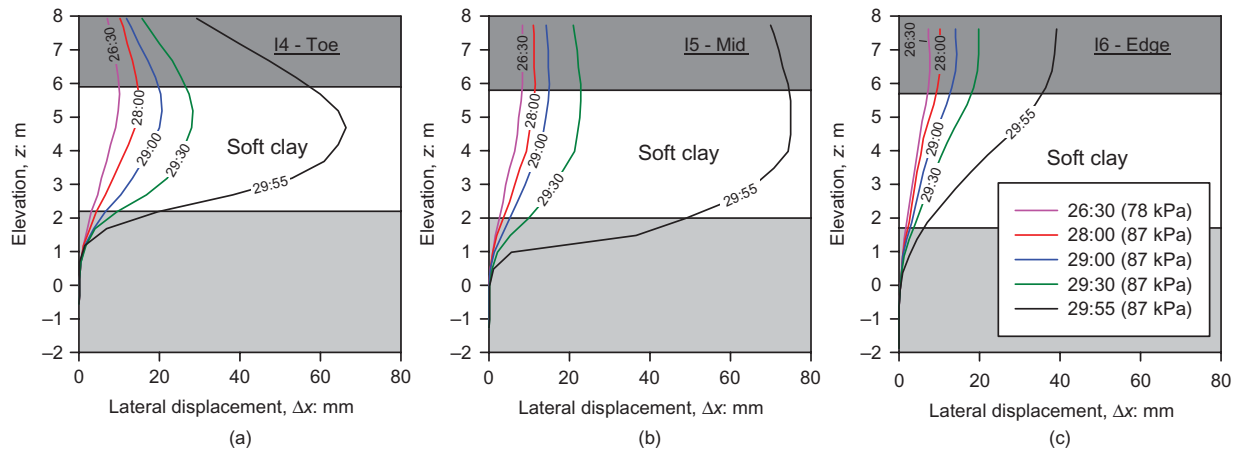
Fig. 13. Horizontal displacement measurements in the foundation: (a) at embankment toe; (b) at midpoint between embankment and ditch; (c) at edge of ditch

yielding process that were recorded in the foundation soil by inclinometers at the toe, mid and edge locations are provided in Fig. 13. Fig. 14 shows the vertical displacement measurements that were recorded by settlement tubes at the ground surface during the same time frame, along the embankment crest and perpendicular to the embankment along section A–A.

As shown in Fig. 13, the horizontal displacements that occurred were dominated by movement in the soft clay layer. Some significant movements were also observed in the underlying stratified silty clay layer, especially at the midpoint location (i.e. inclinometer I5). It is hypothesised that a significant amount of the observed displacements in the silty clay layer may have been caused by inclinometer tube movements in the soft clay layer, which dragged the underlying

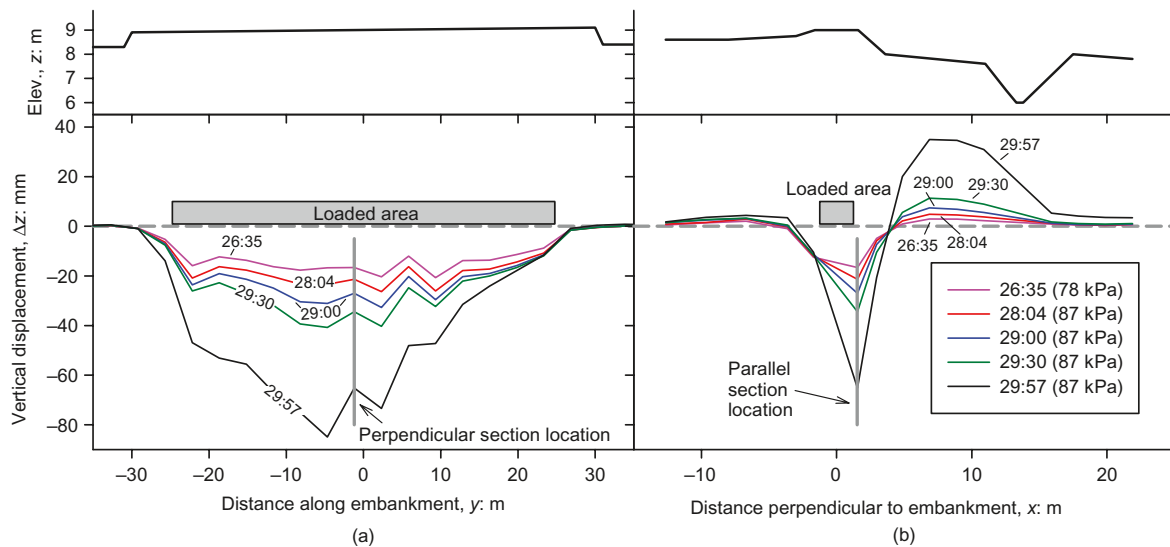
Fig. 14. Vertical displacement measurements at the ground surface: (a) along embankment crest; (b) perpendicular to embankment along section A–A

The vertical displacement response along the embankment centreline exhibited a fairly uniform and consistent trend (Fig. 14(a)), yielding a 'bowl-shaped' depression as movement occurred. Perpendicular to the embankment, the magnitude and direction of the measured vertical displacements were highly dependent on the distance from the embankment (Fig. 14(b)). The embankment exhibited displacement downwards under the load area, while a significant portion of the area between the embankment and the ditch moved upwards. The largest pre-failure settlements (-85 mm) were observed at the embankment crest close to the centre cross-section (Fig. 14(a)). The largest upward displacements ($+35$ mm) occurred close to halfway between the embankment and the ditch, approximately 7 m away from the embankment centreline (Fig. 14(b)). At the embankment toe vertical displacements were very small, which is a result of the particular failure geometry that occurred.
